# WELLGOOD LOOP

## Introduction & Motivation

### Teardown

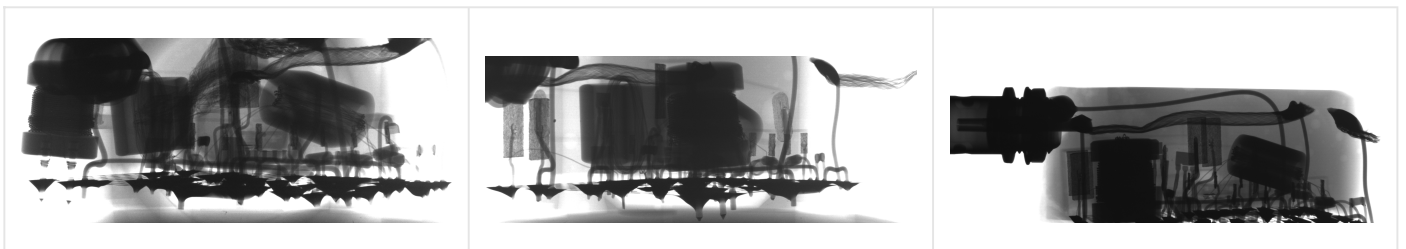
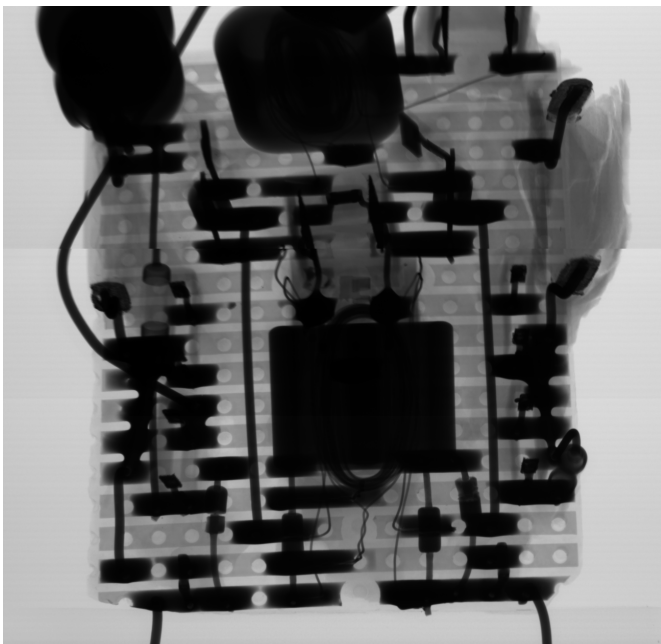
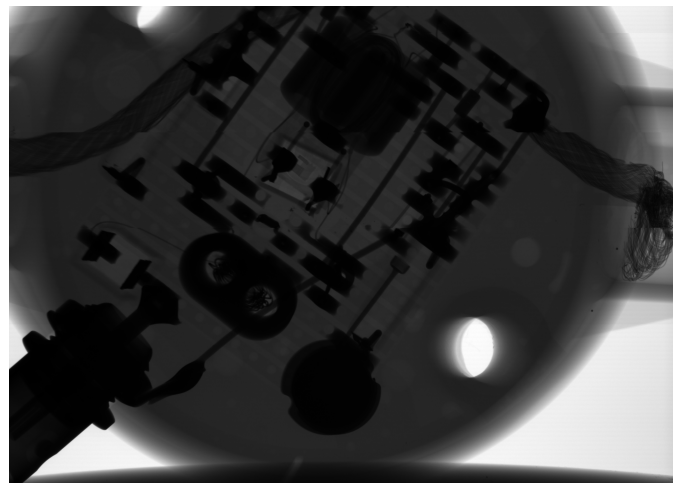
At a local club meet, I was speaking with a friend about my mistake with the loop, and Dave G7UVW who works in an X-Ray lab, offered to x-ray the failed part to assess the feasibility of a repair. You can see these x-rays below. From the x-ray images, it was apparent the device was made on veroboard, with several capacitors, ferrite transformers, and some active transistors.

As a result of being transmitted into, the transistors were blown to pieces, but the parts in place, and, we were able to read the transistor part numbers as being ZTX327.

In getting to the circuit board inside the resin, many of the wires to and from the transformers were broken, one of the ferrites was cracked, as was the circuit-board, probably due to my haste in getting the resin off. Many of remaining components were worse for wear.

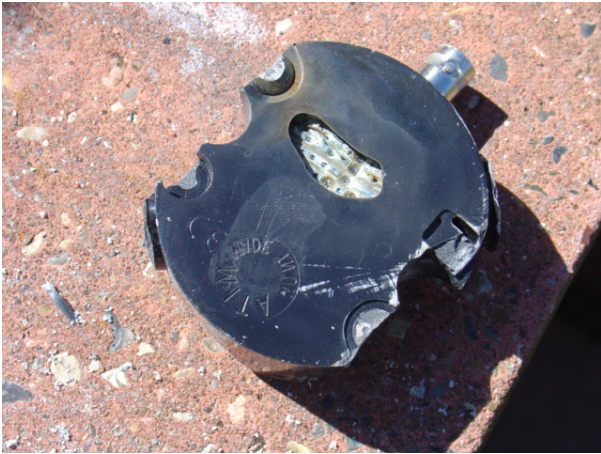
Since this webpage went online, I have been contacted by many amateurs regarding failed loops. Primarily the cause seems to be either transmitting into the receive-only loop, or, water ingress. Derek G3MWO contacted me with pictures of his loop, purchased circa January 2012.

Hole in the resin allowing water ingress

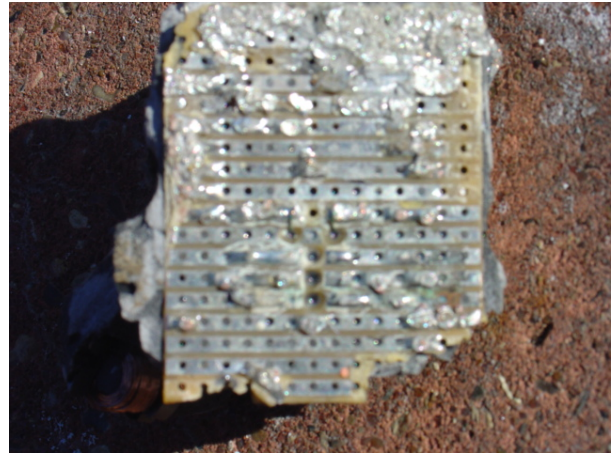
Corrosion on the PCB from water ingress

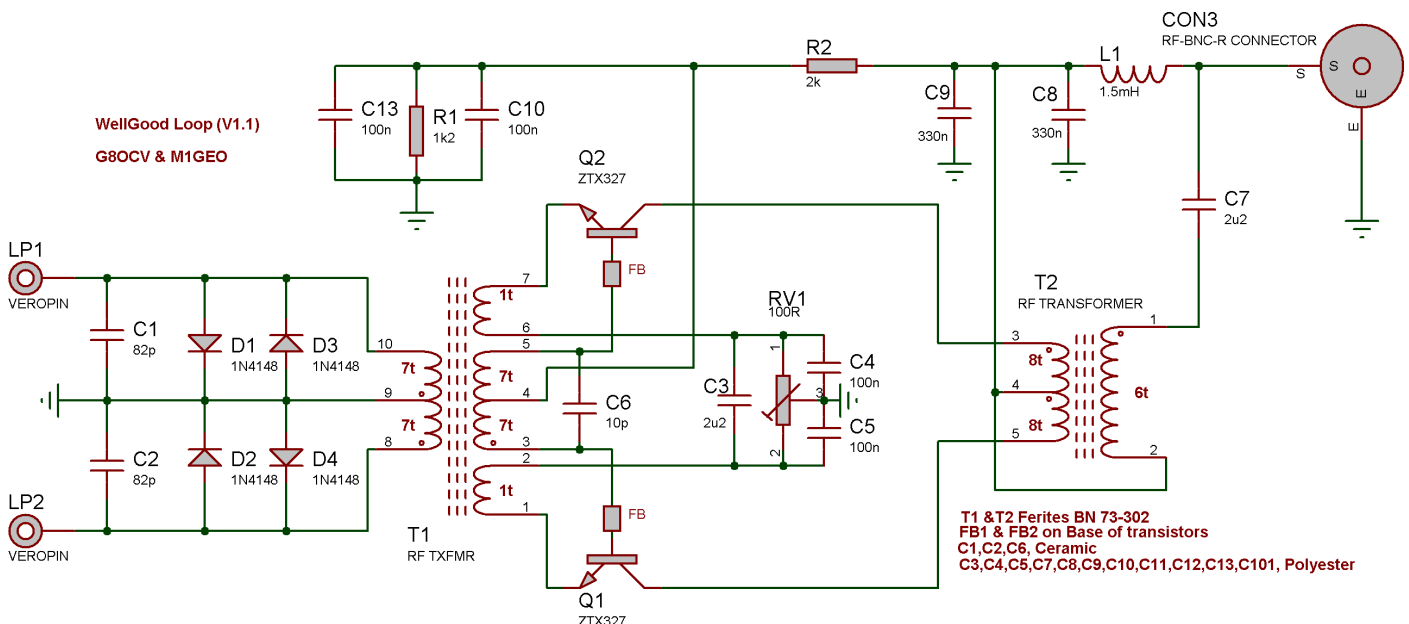
An early version of the PCB had C6 incorrectly placed next to T2. Version 1.1 of the PCB has this issue fixed. In practice, this made no noticeable difference, but will be correct on future versions of the board.

Please note that there is a slight mistake in the the schematic around T1. Follow the instructions for T1 below and all will be fine.

*I am aware of the discrepancy between the schematic and the T1 build instructions – this is to make the core easier to wind and solder in. It does not affect performance since the change is balanced by the reversing of the single turn feedback windings. Hence you are advised to work from the winding instructions below.*

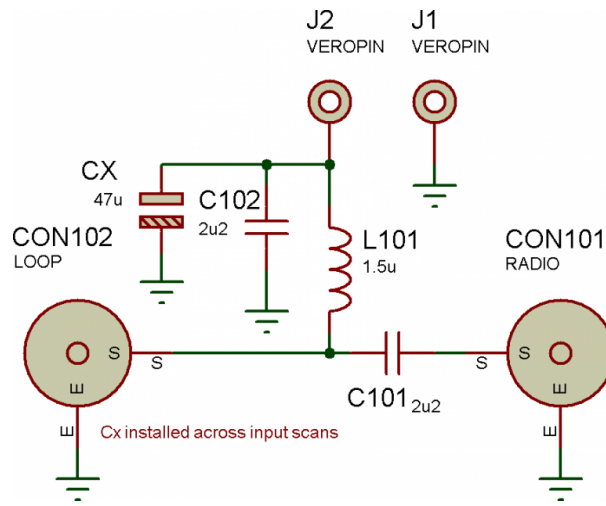
Components for the Bias-T board.

Cx\* is connected cross the input terminals of the bias tee PCB.

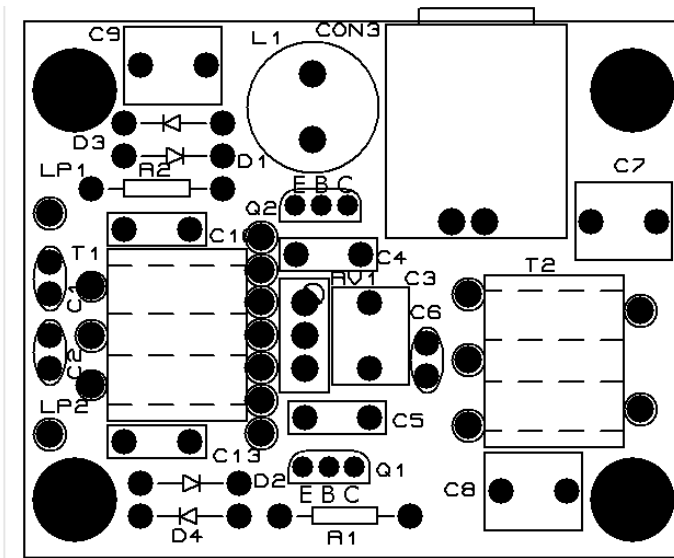
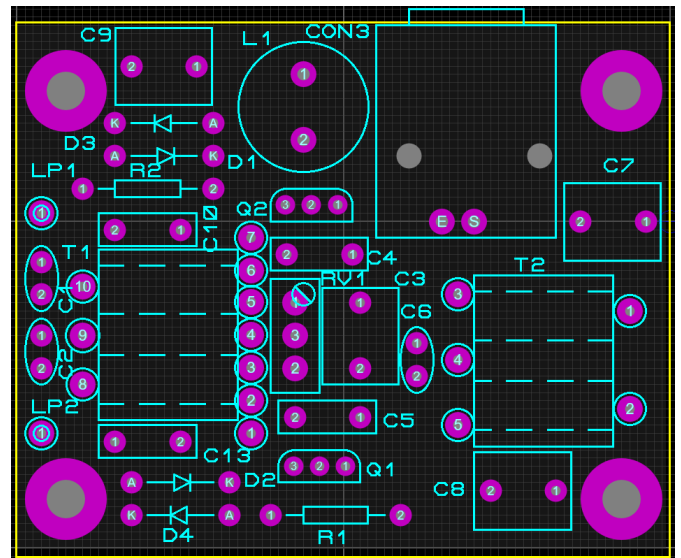
Note that on this version 1.0 board, that C6 is incorrectly positioned. It should be installed between the two transistor bases, across pins 3 and 5 on T1. Version 1.0 boards were red in colour. I may have spare V1.1 boards; if you are interested in a board to repair a loop, then Contact Me.

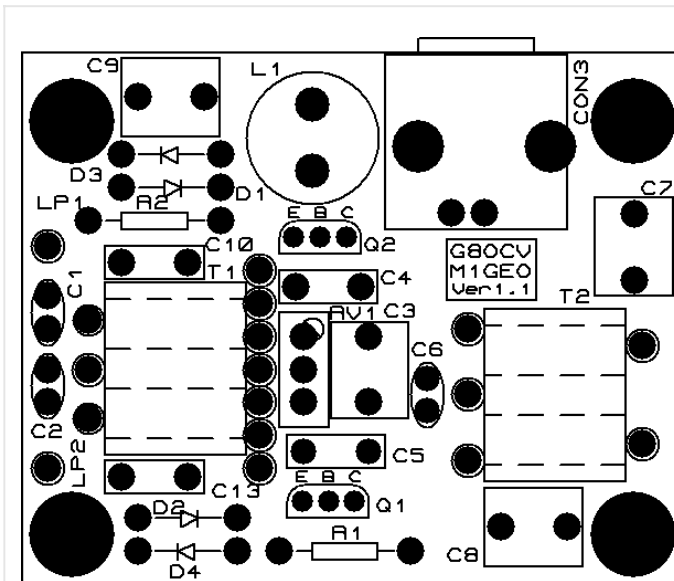
WellGood Loop (V1.1) PCB placement diagram

Due to the capacitor miss-placement on Version 1.0 above, an updated version of the board was produced. These boards are blue in colour. Some spare production area enabled us to also include a Bias-Tee board. The distance between centres for the two bias tee connectors (CON101 and CON102) is 35mm.

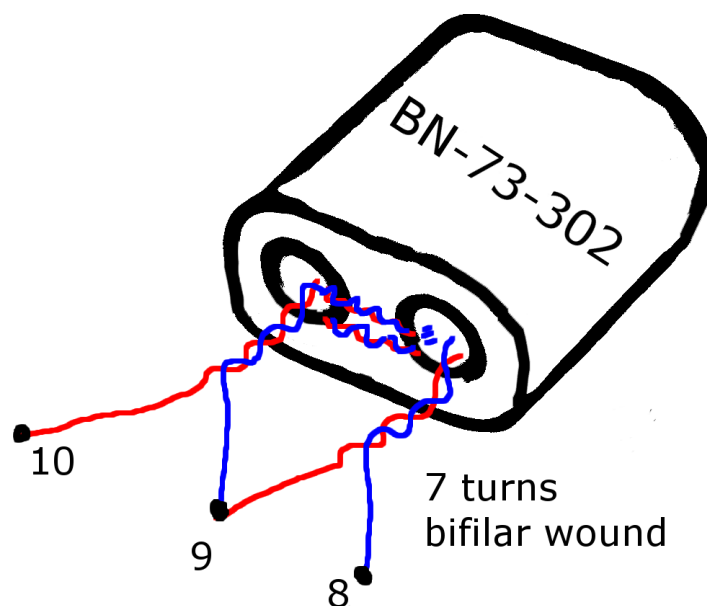
The first job is to wind the loop (input) side of T1. Wind 7 turns of the bifilar wire around the BN-73-302 core, creating a centre-tapped point, as shown below. The numbers refer to the solder pads in the colour placement diagram.

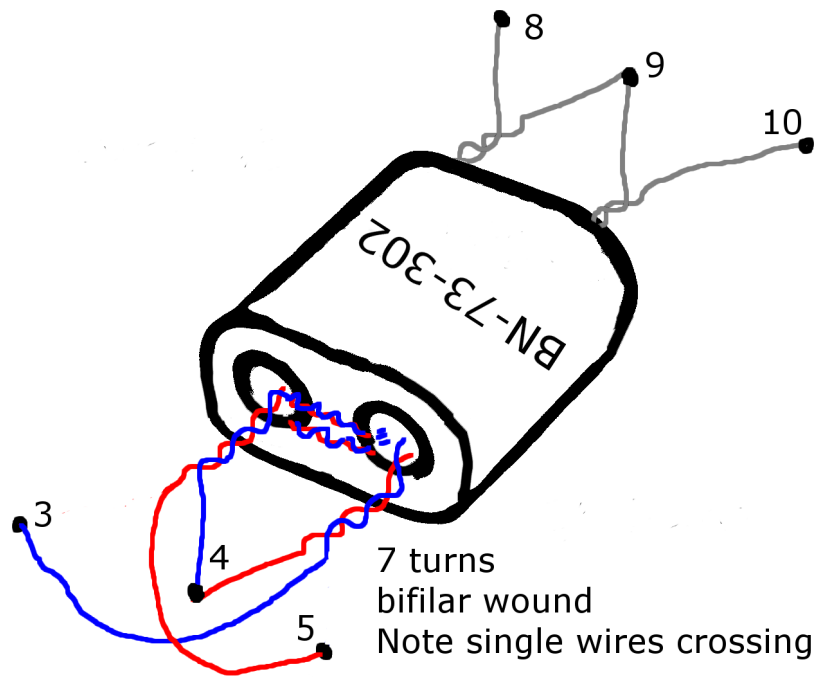
Flip the core around and repeat the process to make the first of the secondary windings for T1. As with the primary, two of the wires are connected together to form the centre-tap and will connect to

pin 4. The two remaining wires need to be crossed to prevent the circuit from oscillating.

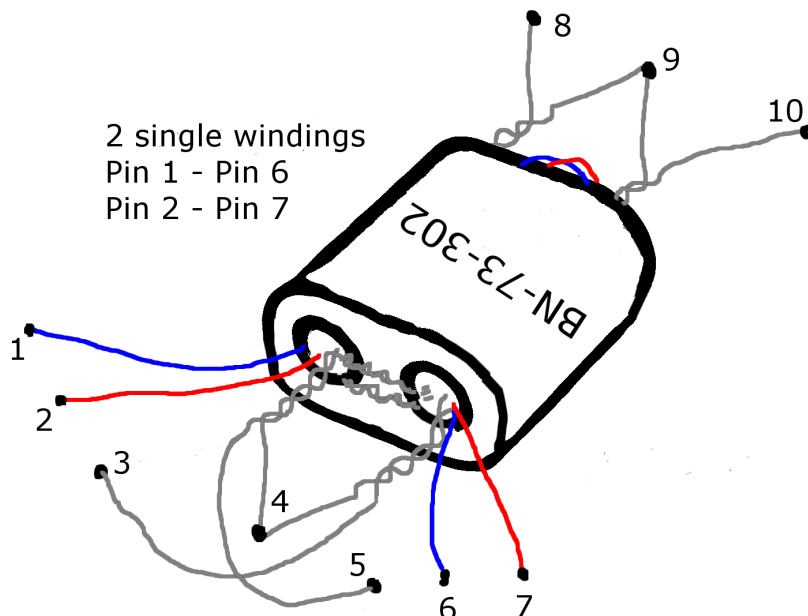
At this point, it may be easier to mount T1 transformer to the PCB and add the two single turn windings on afterwards – with a binocular core, one turn is a 'U' loop through both holes. These last two windings are made from a single piece of wire (not bifilar), which go in through one side of the core, and out of the other. One of the windings goes from pin 1 to pin 6, and the other between pin 2 and pin 7, as shown.

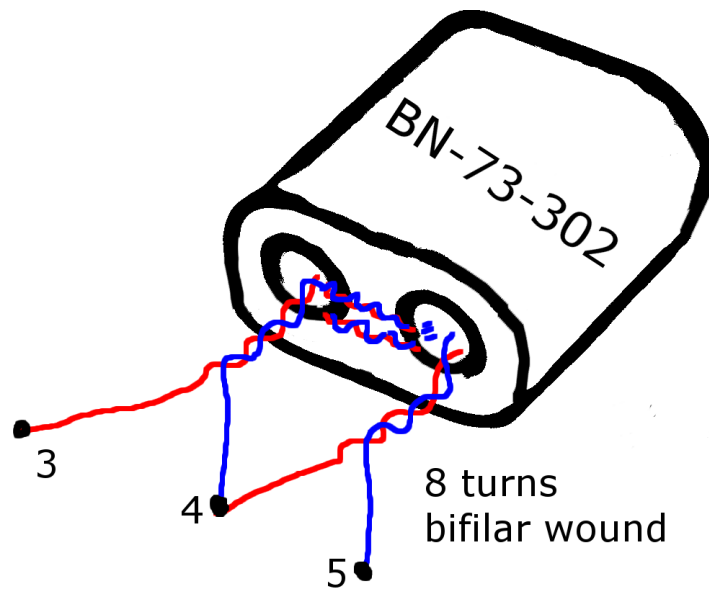
Using the same bifilar wire as you made for T1, wind 8 turns for the primary of transformer T2. Separate the two strands and create the centre-tap as before, shown below. As with T1, I used 0.25

mm diameter enamelled copper wire but the original was 0.2 mm diameter.

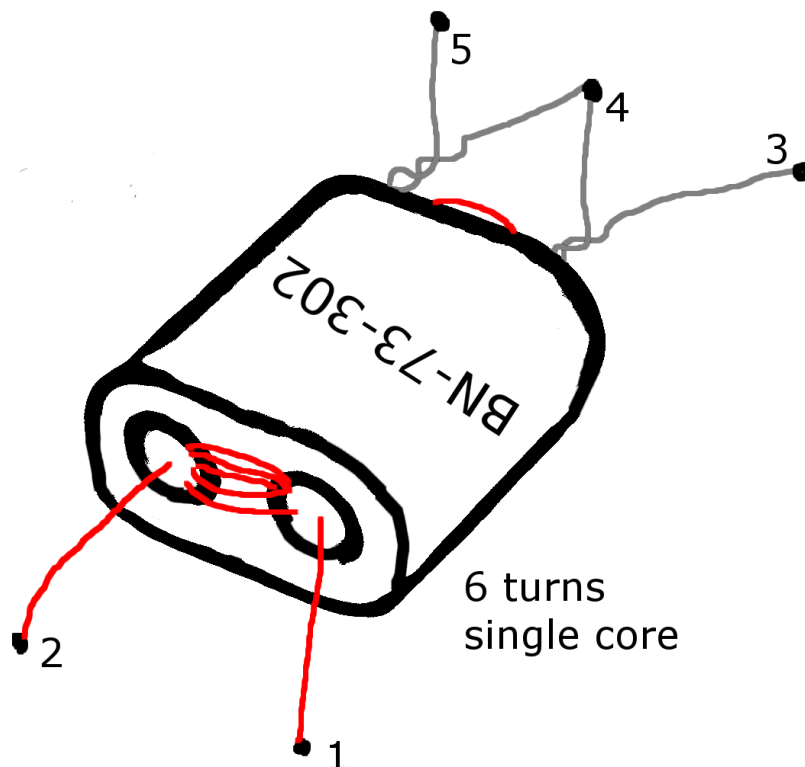
The secondary winding of T2 is 6 turns of standard (single core) enameled copper wire, as shown below.

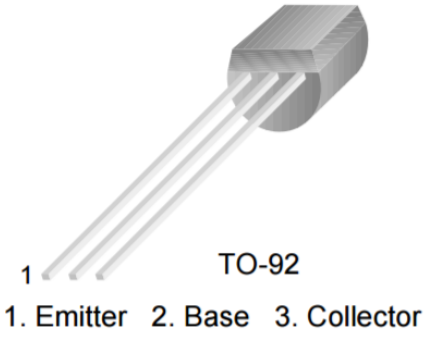
ZTX327 / ZTX653	PN2222

The transistors used in the original design were ZTX327, and so this board is designed to fit those. These are now obsolete and are quite expensive to acquire from sources such as eBay. A ZTX653 has a matching pinout with suitable characteristics, and would be a direct drop-in replacement for the

ZTX327. Preliminary tests were done with an MPSH10, but the pinout is different, and so require some tweaking to fit to the board. The original ZTX327 transistors had a hFE-min of 15. It is important not to have too high forward current gain (hFE) on the transistors, as this will disturb the correct biasing of the transistors. The pinouts are shown below. Dave GW3WCV writes in (see Feedback section below) to say that he had success with PN2222A devices, which improve the higher frequency performance, too. I have since been using PN2222 devices with improved results and it is pin-compatible with the ZTX327. The PN2222 is my preferred choice.

If using MPSH10's on the PCB, you should switch the base and emitter wires around. The ferrite bead on the base will prevent them shorting.
